GOLDEN RULE HOME INSPECTIONS

Inspection Report

Prepared For:
Park Apartments Inc
Nancy Mattis

Property Address:
24201 Walden Center Dr
Bonita Springs, FL 34134

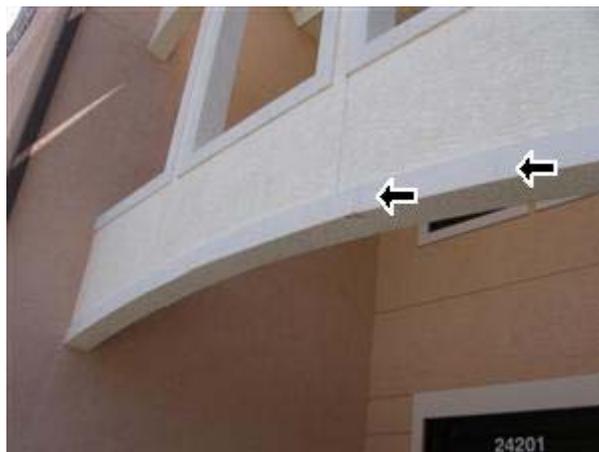
2.0 Picture 1

2.0 Stucco has cracks some of which are on the exterior wall of the building that must be filled to prevent water intrusion. Those on decorative walls are just cosmetic.

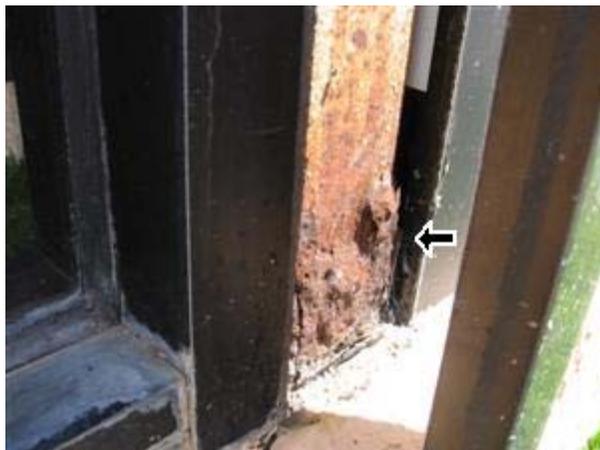
2.0 Picture 8

The aluminum cap in between the two windows shown on the south side of the building has slipped exposing a structural steel column to the weather. The steel is badly rusted and has signs of extreme corrosion. A structural engineer should evaluate whether or not the steel column is OK.

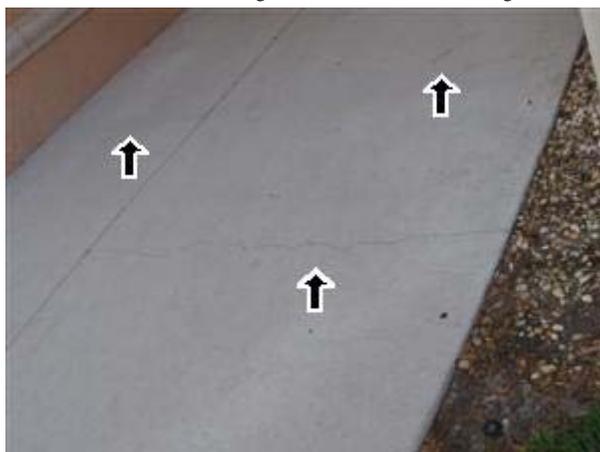
2.3 Picture 1

2.3 Normal settlement cracking on sidewalk around building.

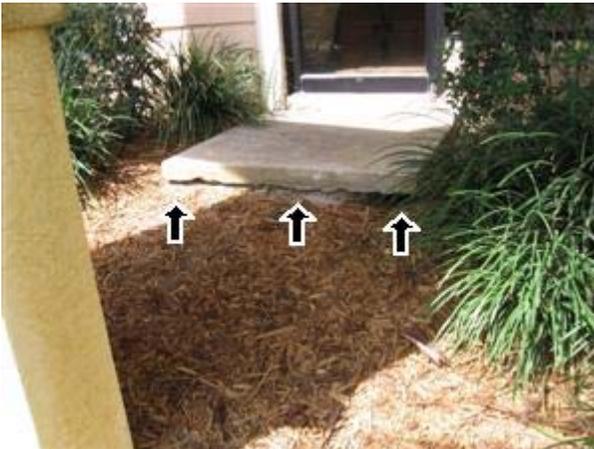
2.4 Picture 1

2.4 The ground has eroded under the two landings at the exterior doors facing US 41. Both areas require the mulch to be pulled back, fill dirt added, and then mulch re-applied.

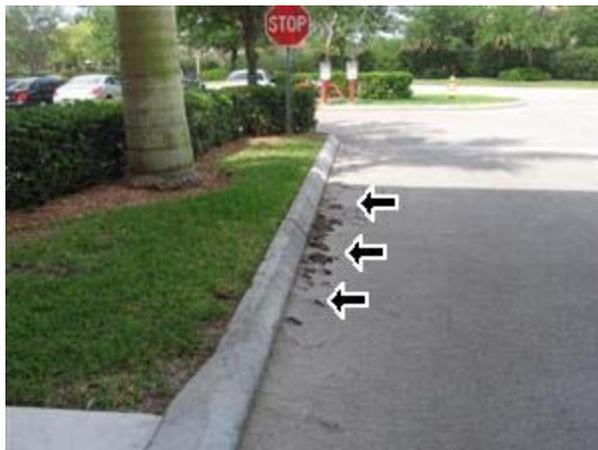
2.7 Picture 1

2.7 Asphalt at exit for drive through at the bank by the stop sign is buckling. The roots from the palm tree appear to be pushing up through the asphalt. A section of curb appears to be slightly displaced in area shown.

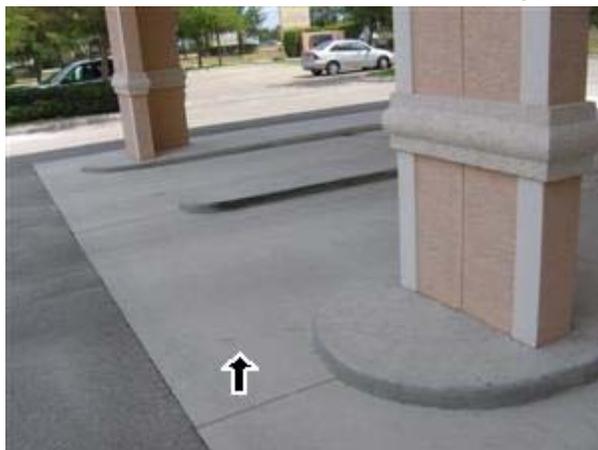
2.7 Picture 2

Drive-thru bank teller concrete has normal settlement cracking.

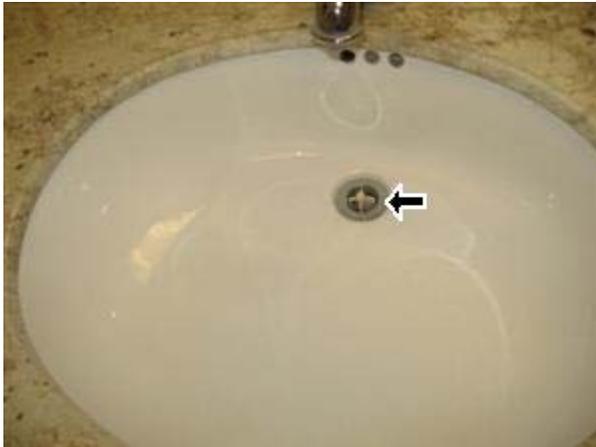
4.8.B Picture 1

4.8.B Top of left sink stopper is missing.

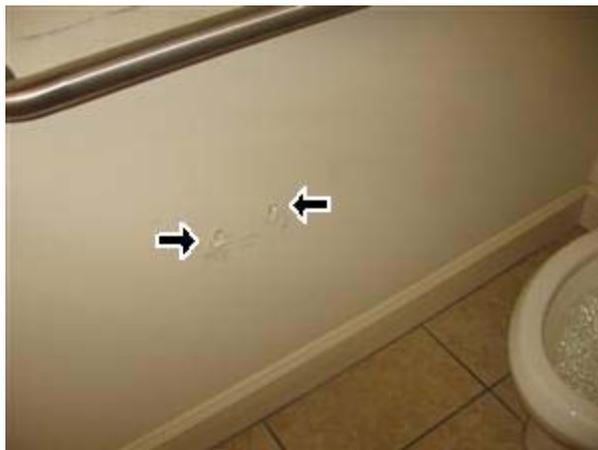
4.5.C Picture 1

4.5.C Handicap area is missing the toilet paper holder and has holes in wall where it used to be located.

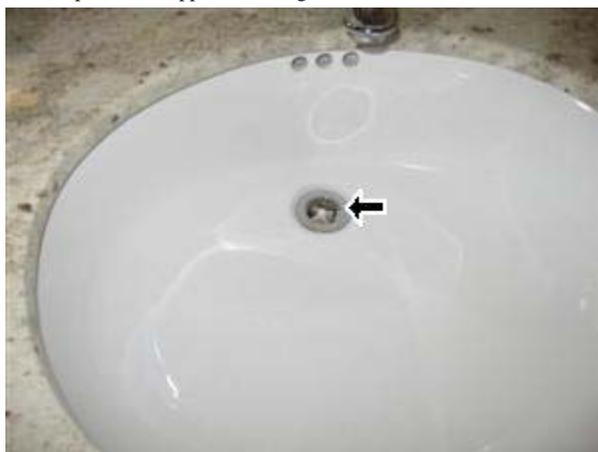
4.8.C Picture 1

4.8.C Top of sink stopper is missing.

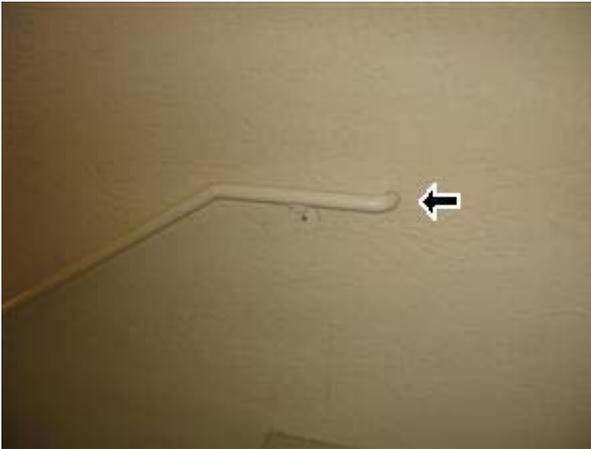
5.0.A Picture 1

5.0.A Railing at SE stairwell at intermediate landing is loose.

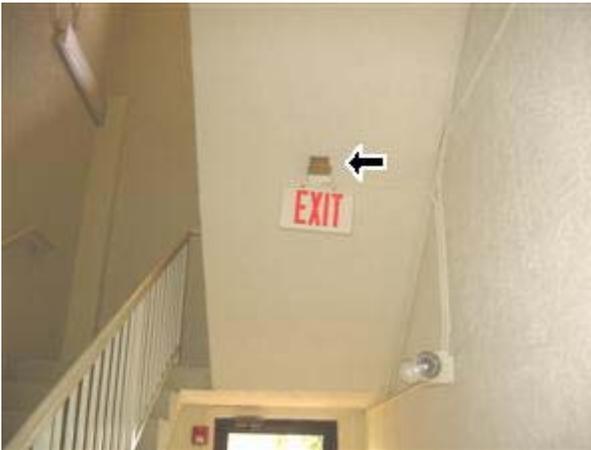
5.4.A Picture 1

5.4.A Exit sign is supported by a piece of 2x6.

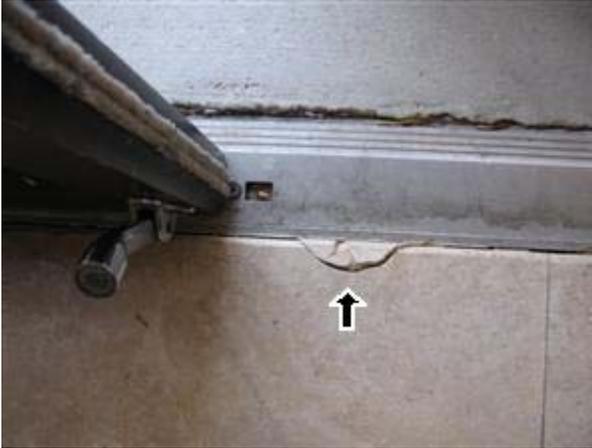
5.2.B Picture 1

Comments:**5.2.B** Floor tile is cracked at front lobby door.

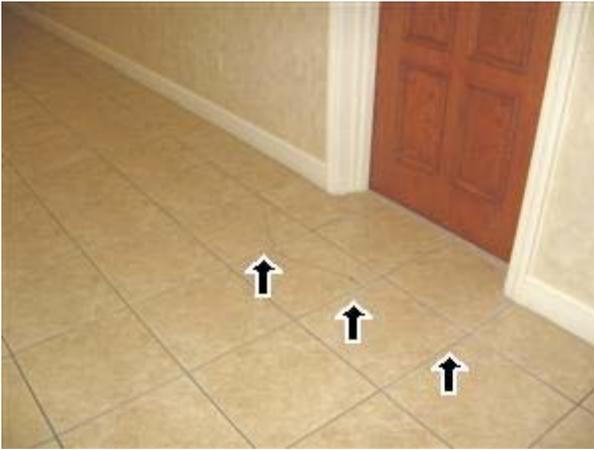
5.2.C Picture 1

Comments:**5.2.C** Three tiles in front of the mechanical room door and one in front of the elevator are cracked. This is a sign of the floor settling.

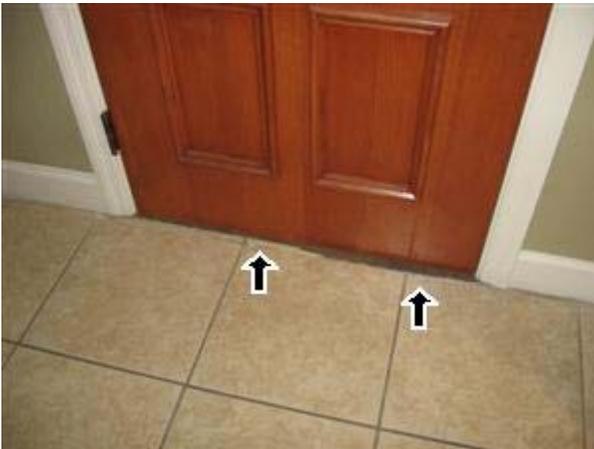
5.2.C Picture 4

In the north section of the hall at Victoria Spina's door the tiles at the carpet are broken and east of the door at the base molding excessive grout has been used and is breaking down.

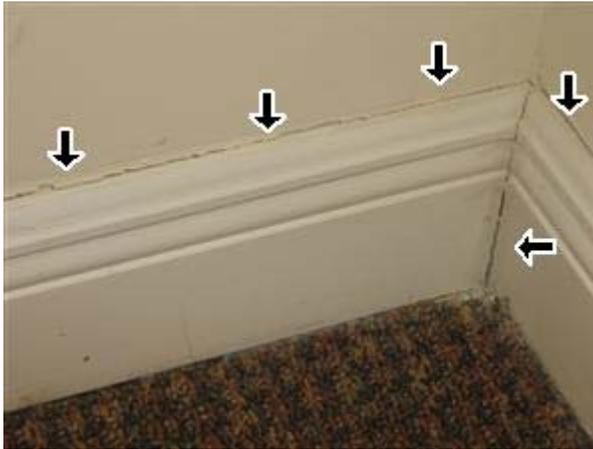
5.5.D Picture 1

5.5.D Base molding along window wall in right office facing US 41 is separating from the sheet rock walls and has a gap in corners. This is usually caused by water intrusion. A moisture meter was used and wall was dry at time of inspection. It has only rained twice in the last 4 month or so. If leak is from rain it would read dry.

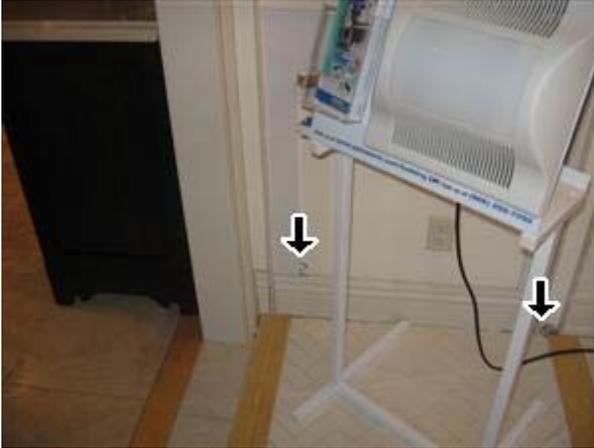
5.1.E Picture 1

5.1.E Sheet rock is damaged in the bathroom fixture showroom and needs to be repaired.

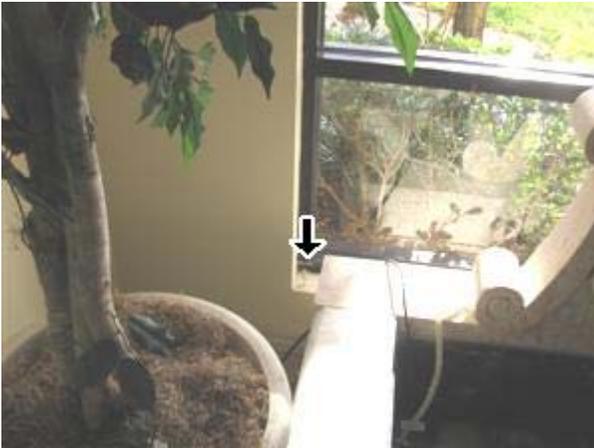
5.1.E Picture 2

Sheetrock at window by the fountain in the specialty area is peeling away. It is not wet or soft.

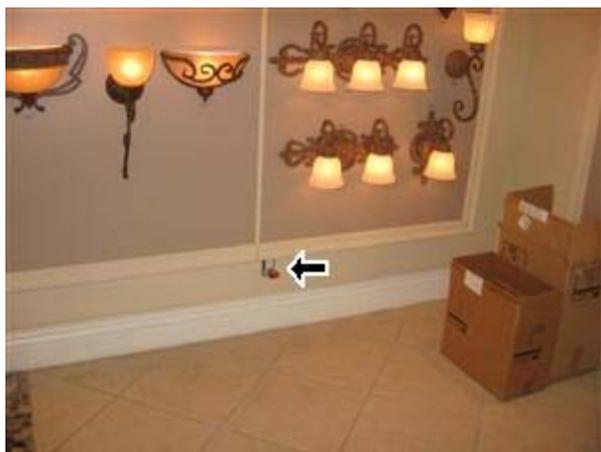
5.6.E Picture 1

5.6.E Cover plates are missing for the wall outlets in the lighting fixture showroom.

The same in the computer control room and the promotion room with the TV

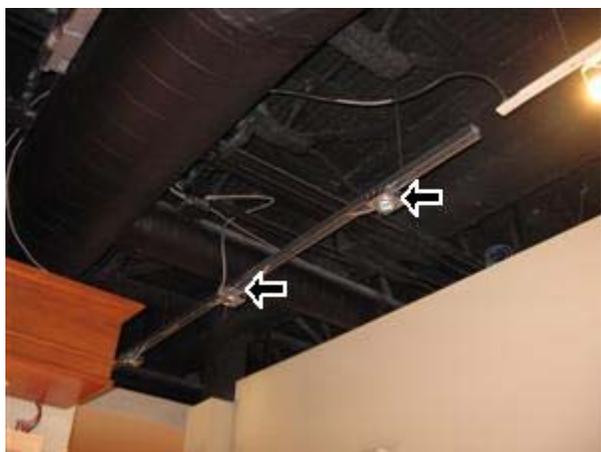
5.6.E Picture 5

Light cover plates are missing for the track lights in the light fixture area.

This is also true for the ceiling and vanity lights in the bathroom areas.

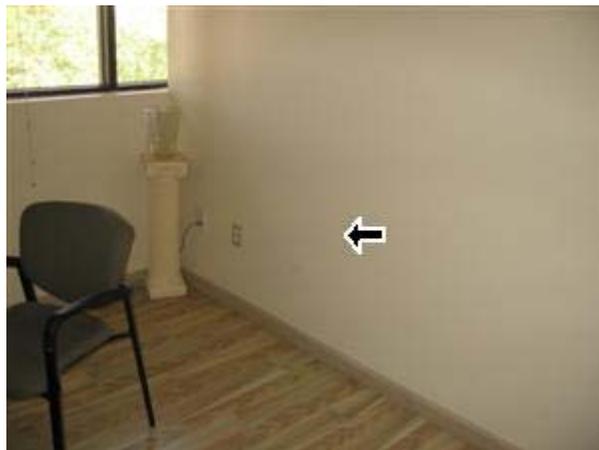
5.1.H Picture 1

5.1.H Sheetrock in Kim Williams office has a hole in it. This will need repair.

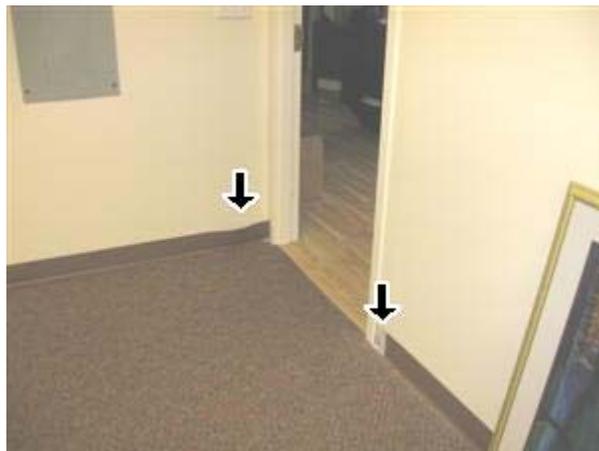
5.5.H Picture 1

5.5.H Base molding is missing and separated from wall at entrance to Kim Williams office.

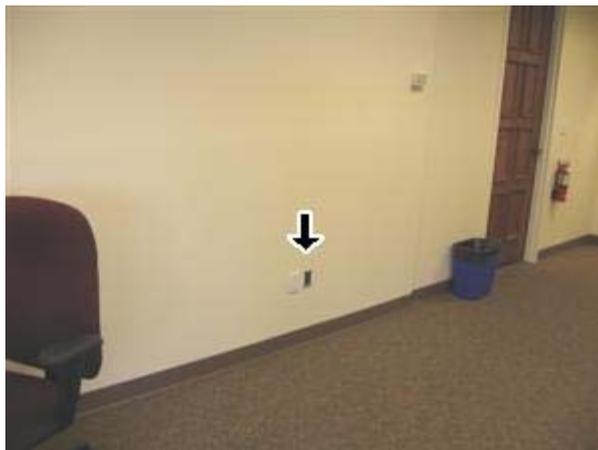
5.6.H Picture 1

5.6.H Two outlet(s) are missing cover-plate at south and north walls in east section of the office.

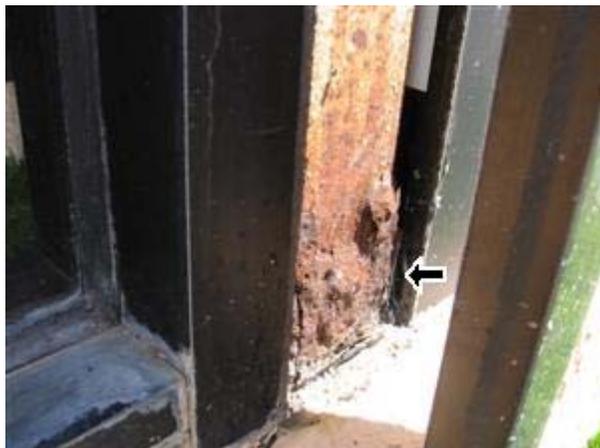
7.1 Picture 1

7.1 The aluminum cap in between the two windows shown on the south side of the building has slipped exposing a structural steel column to the weather. The steel

is badly rusted and has signs of extreme corrosion. A structural engineer should evaluate whether or not the steel column is OK.

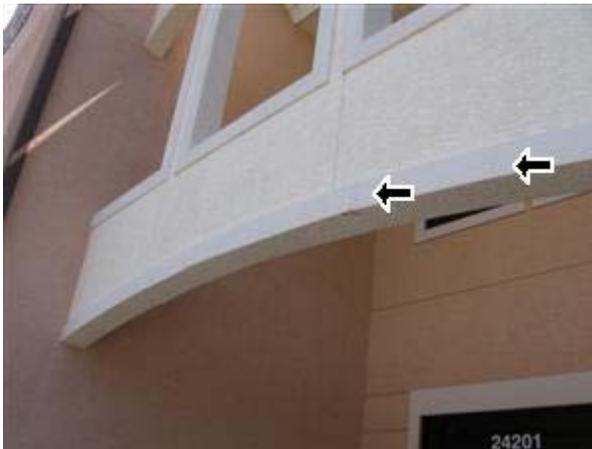
2.0 Picture 1

Stucco has cracks some of which are on the exterior wall of the building that must be filled to prevent water intrusion. Those on decorative walls are just cosmetic.

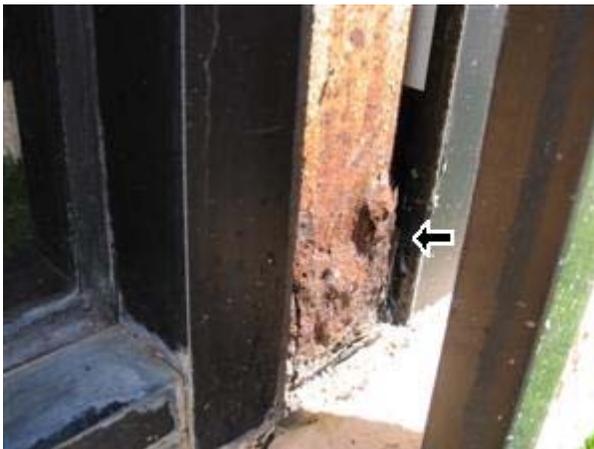
2.0 Picture 8

The aluminum cap in between the two windows shown on the south side of the building has slipped exposing a structural steel column to the weather. The steel is badly rusted and has signs of extreme corrosion. A structural engineer should evaluate whether or not the steel column is OK.

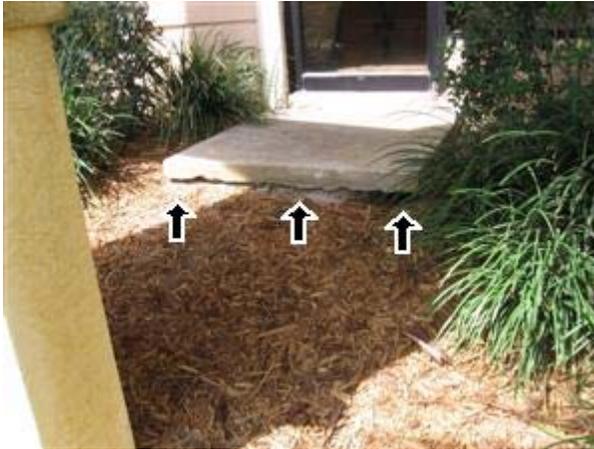
2.4 Picture 1

The ground has eroded under the two landings at the exterior doors facing US 41. Both areas require the mulch to be pulled back, fill dirt added, and then mulch re-applied.

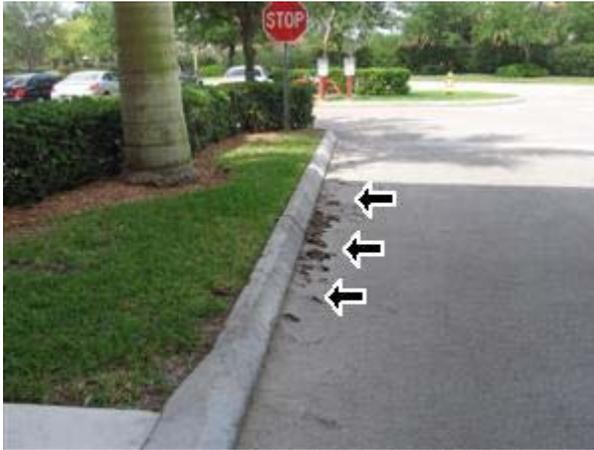
2.7 Picture 1

Asphalt at exit for drive through at the bank by the stop sign is buckling. The roots from the palm tree appear to be pushing up through the asphalt. A section of curb appears to be slightly displaced in area shown.

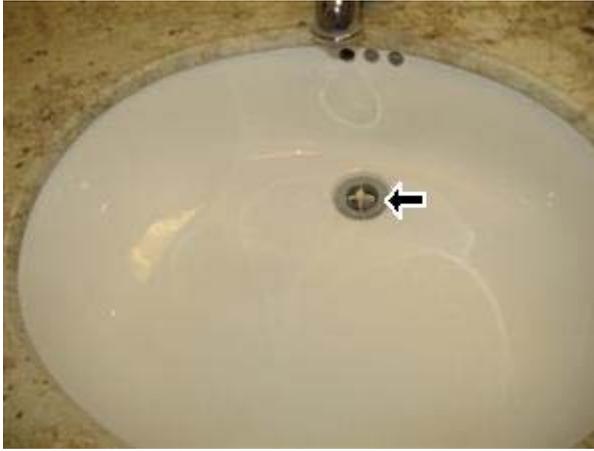
4.8.B Picture 1

Top of left sink stopper is missing.

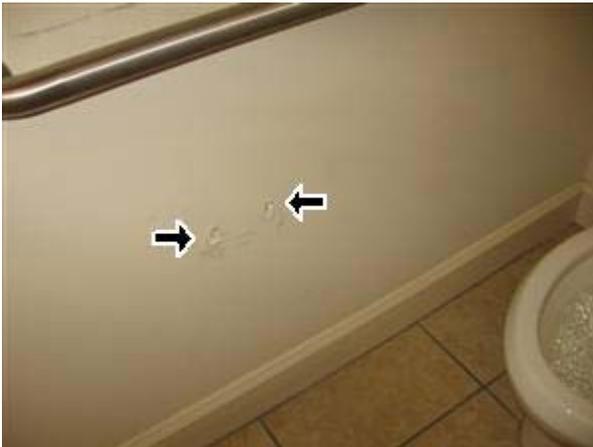
4.5.C Picture 1

Handicap area is missing the toilet paper holder and has holes in wall where it used to be located.

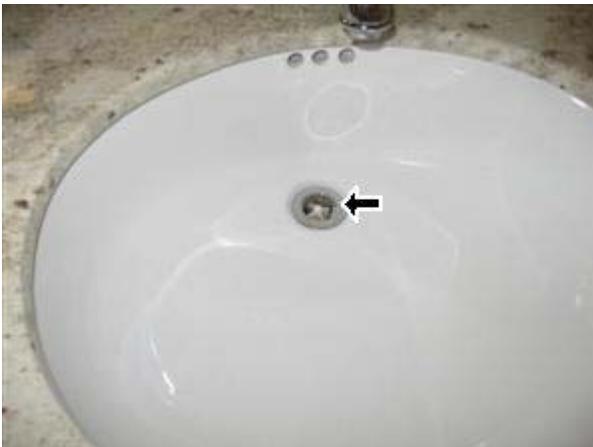
4.8.C Picture 1

Top of sink stopper is missing.

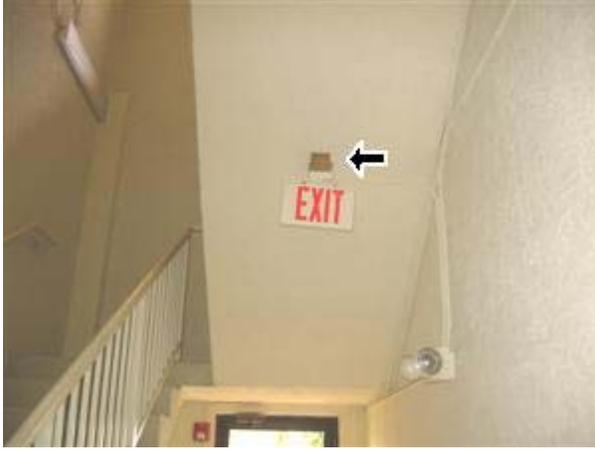
5.4.A Picture 1

Exit sign is supported by a piece of 2x6.

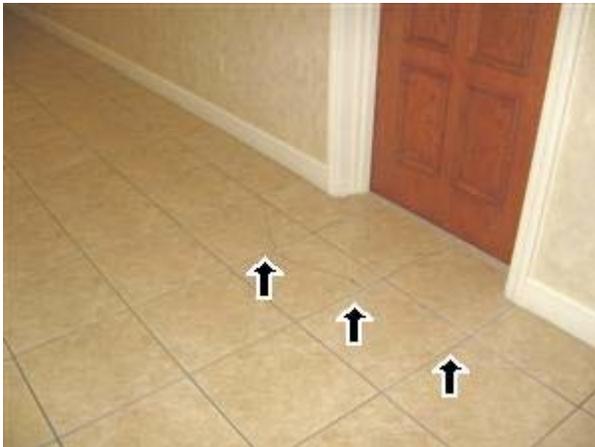
5.2.C Picture 1

Three tiles in front of the mechanical room door and one in front of the elevator are cracked. This is a sign of the floor settling.

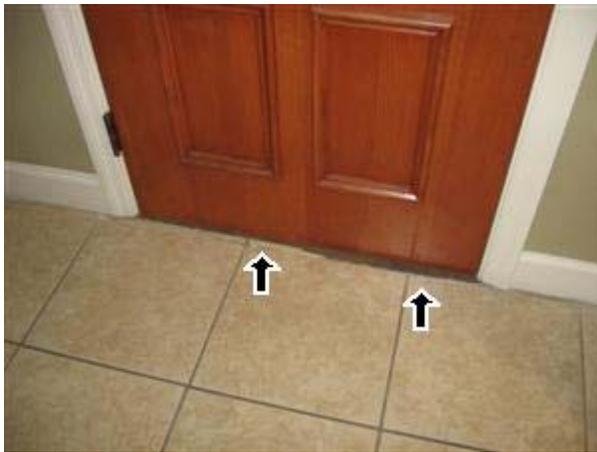
5.2.C Picture 4

In the north section of the hall at Victoria Spina's door the tiles at the carpet are broken and east of the door at the base molding excessive grout has been used and is breaking down.

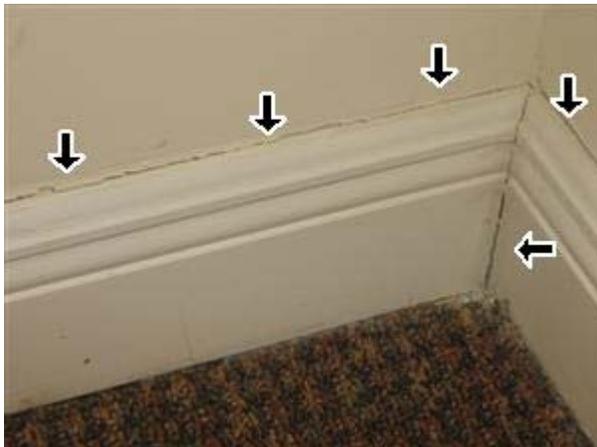
5.5.D Picture 1

Base molding along window wall in right office facing US 41 is separating from the sheet rock walls and has a gap in corners. This is usually caused by water intrusion. A moisture meter was used and wall was dry at time of inspection. It has only rained twice in the last 4 month or so. If leak is from rain it would read dry.

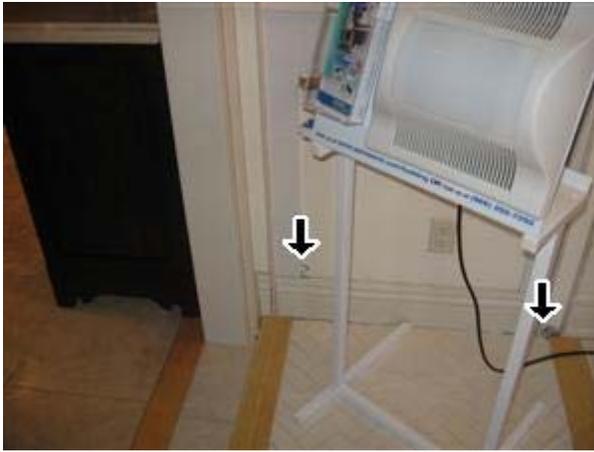
5.1.E Picture 1

Sheet rock is damaged in the bathroom fixture showroom and needs to be repaired.

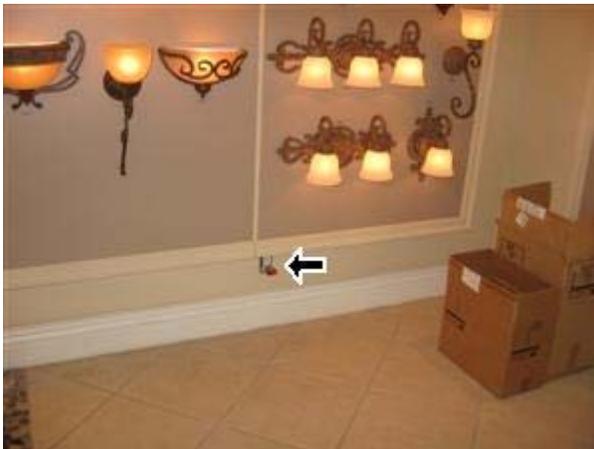
5.6.E Picture 1

Cover plates are missing for the wall outlets in the lighting fixture showroom.

The same in the computer control room and the promotion room with the TV

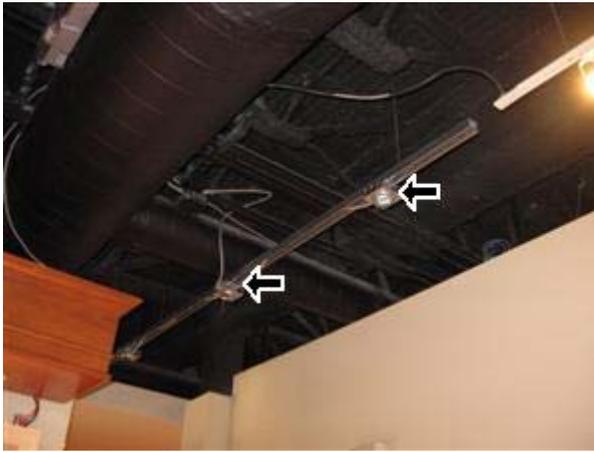
5.6.E Picture 5

Light cover plates are missing for the track lights in the light fixture area.

This is also true for the ceiling and vanity lights in the bathroom areas.

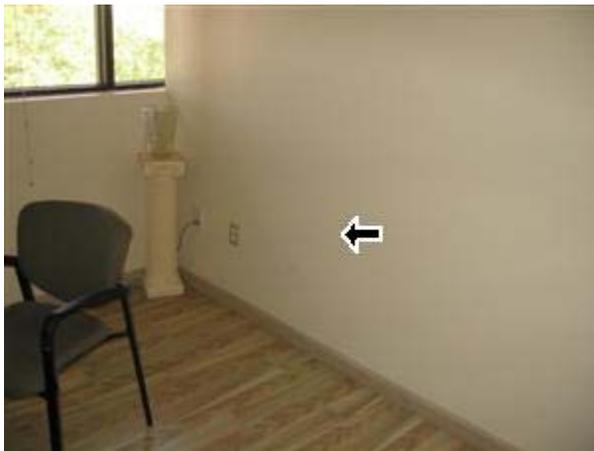
5.1.H Picture 1

Sheetrock in Kim Williams office has a hole in it. This will need repair.

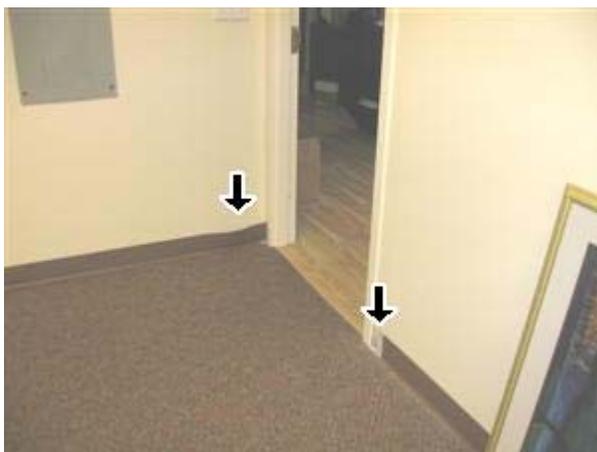
5.5.H Picture 1

Base molding is missing and separated from wall at entrance to Kim Williams office.

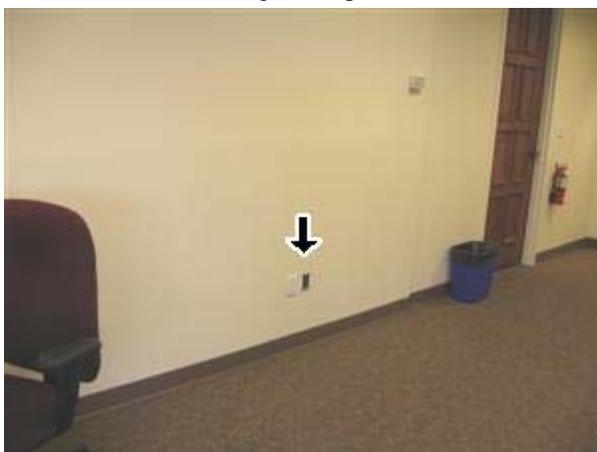
5.6.H Picture 1

Two outlet(s) are missing cover-plate at south and north walls in east section of the office.

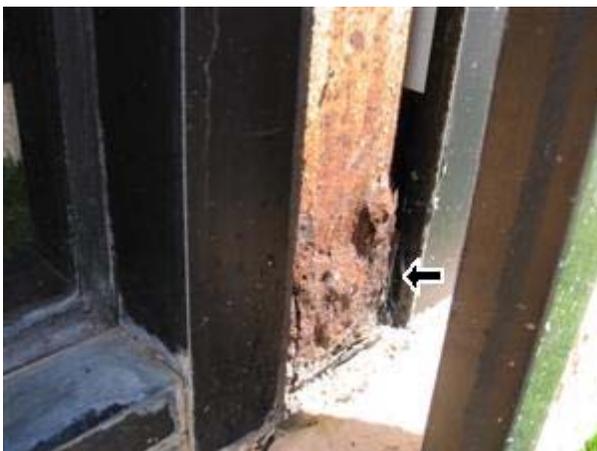
7.1 Picture 1

The aluminum cap in between the two windows shown on the south side of the building has slipped exposing a structural steel column to the weather. The steel is badly rusted and has signs of extreme corrosion. A structural engineer should evaluate whether or not the steel column is OK.

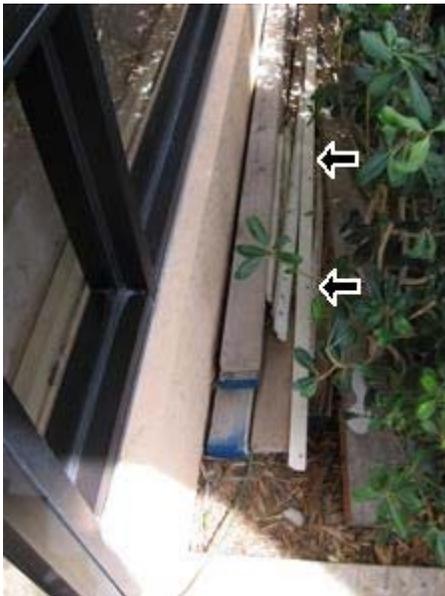
2.0 Picture 7

Along the side of the building facing US 41 there is lumber stored. All wood should be removed ASAP. It will attract termites.

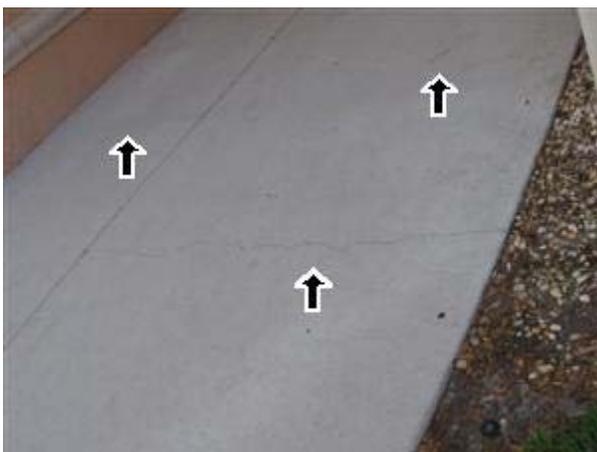
2.3 Picture 1

Normal settlement cracking on sidewalk around building.

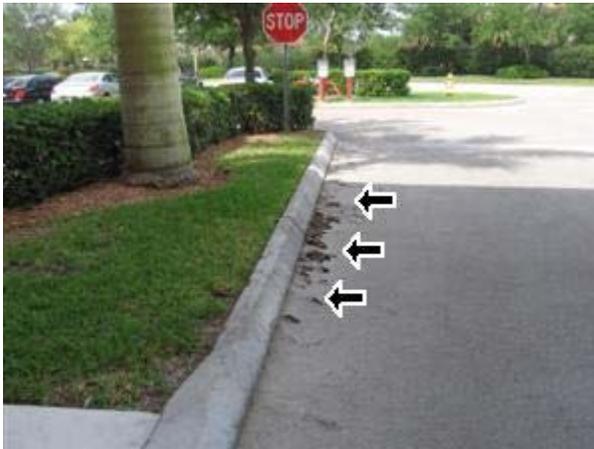
2.7 Picture 1

Asphalt at exit for drive through at the bank by the stop sign is buckling. The roots from the palm tree appear to be pushing up through the asphalt. A section of curb appears to be slightly displaced in area shown.

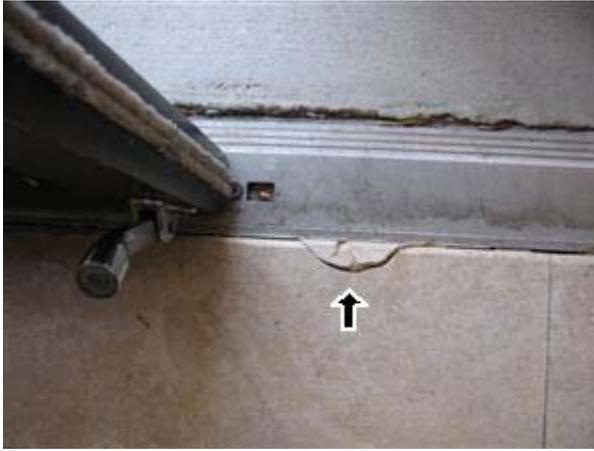
5.2.B Picture 1

Floor tile is cracked at front lobby door.

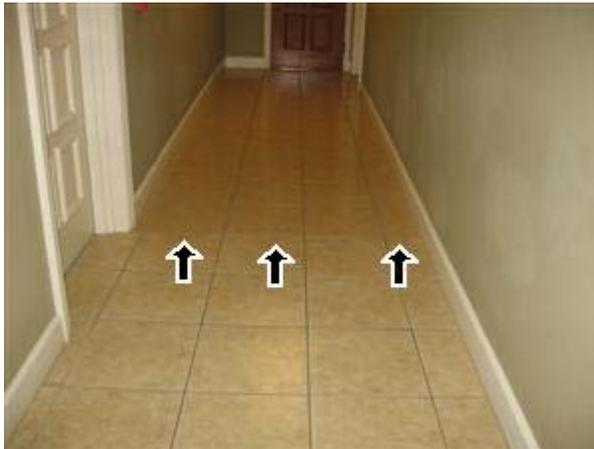
5.2.C Picture 3

In the south section of the hallway from the door to the stairs to the end of the hall the tiles are a different color.
